# Out with the new, in with the old

Lessons learned during the rehabilitation of a 350 mgd pump station

City of Dallas

# Activated Sludge Influent Pump Station

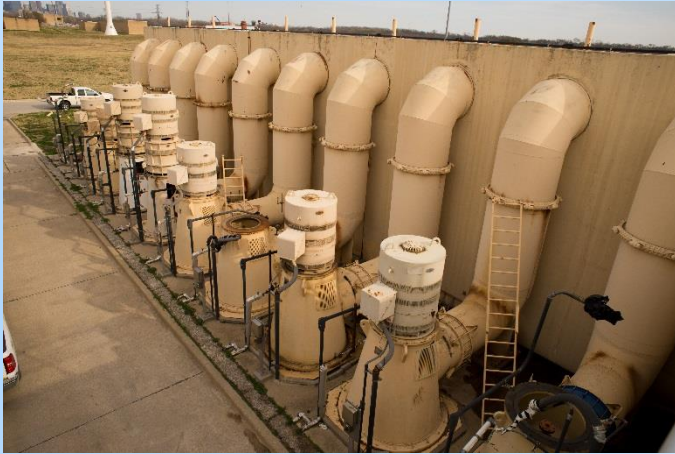
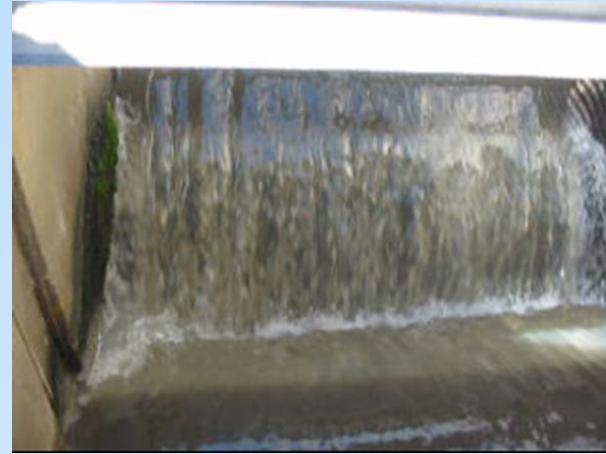
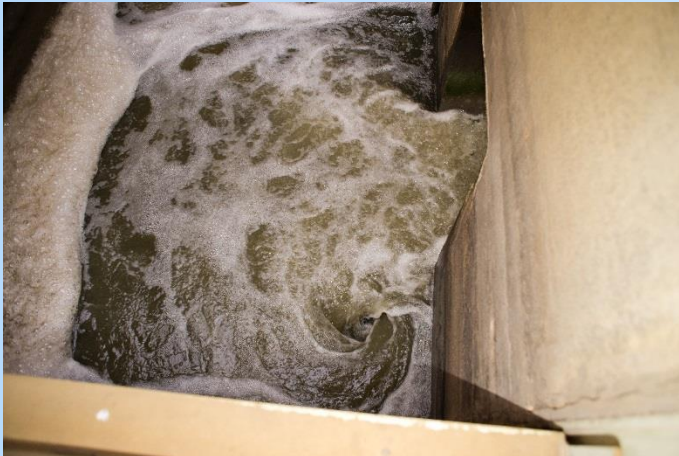
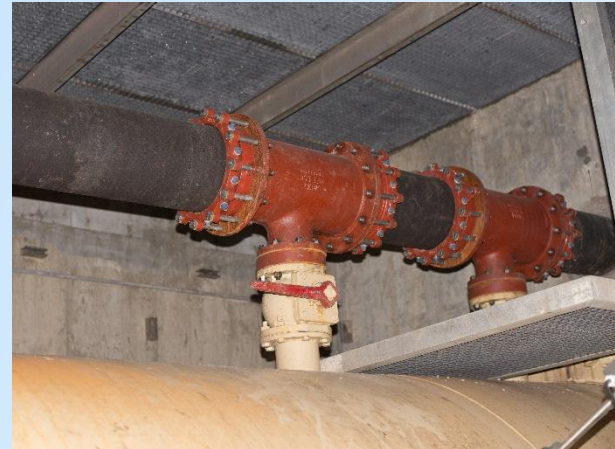
# Aged pumps, hydraulic restrictions, and air entrainment reduced reliability

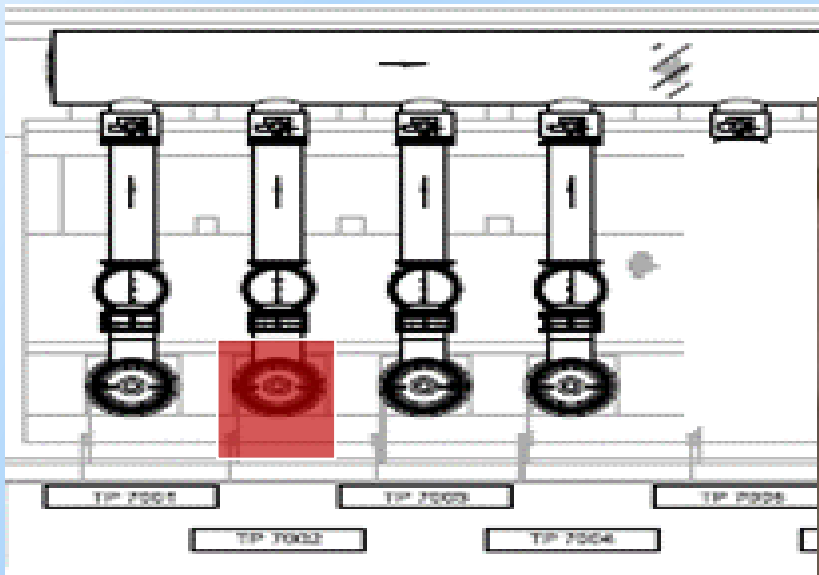
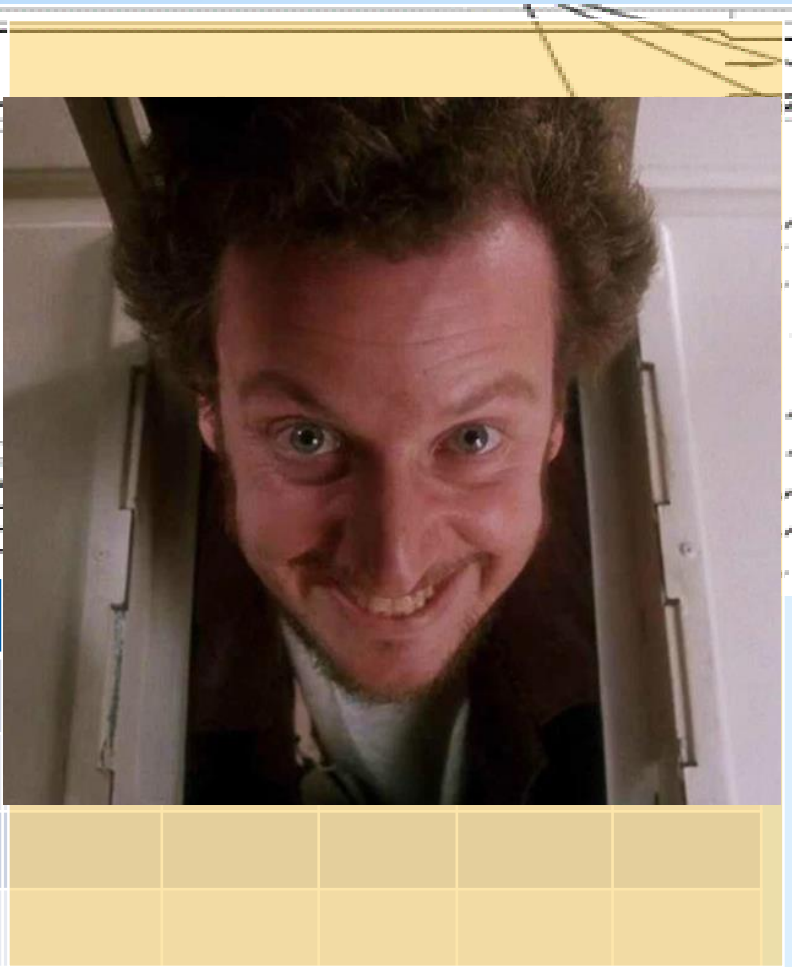
# Couplings begin to fail February 24

Tag	7001	7002	7003	7004	7005
		2/24			
	~150 mgd capacity, new pumps

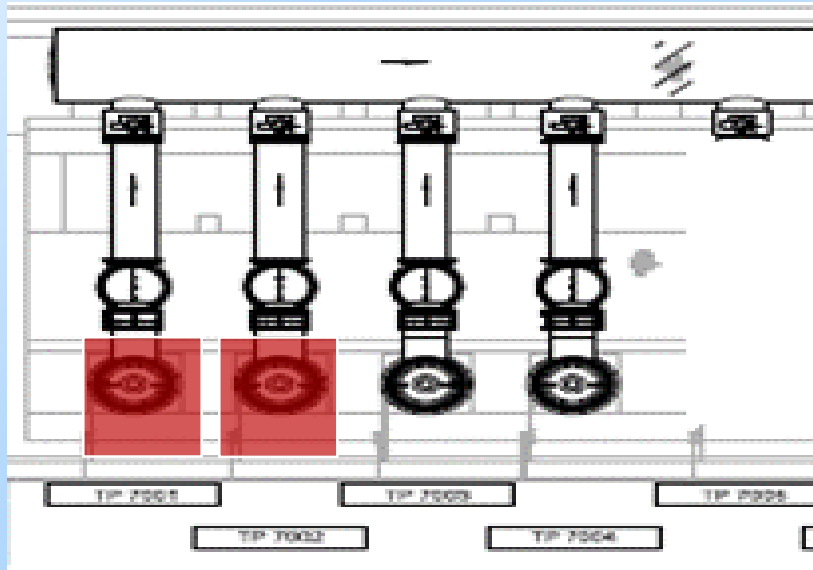
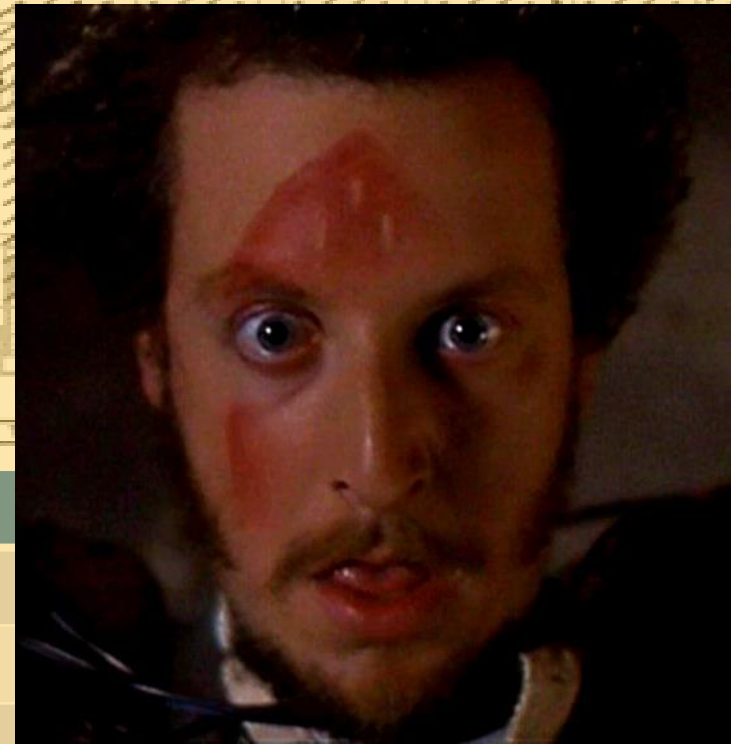
# ...and continue...

Tag	7001	7002	7003	7004	7005
		2/24			
	3/2				
	~100 mgd capacity, new pumps

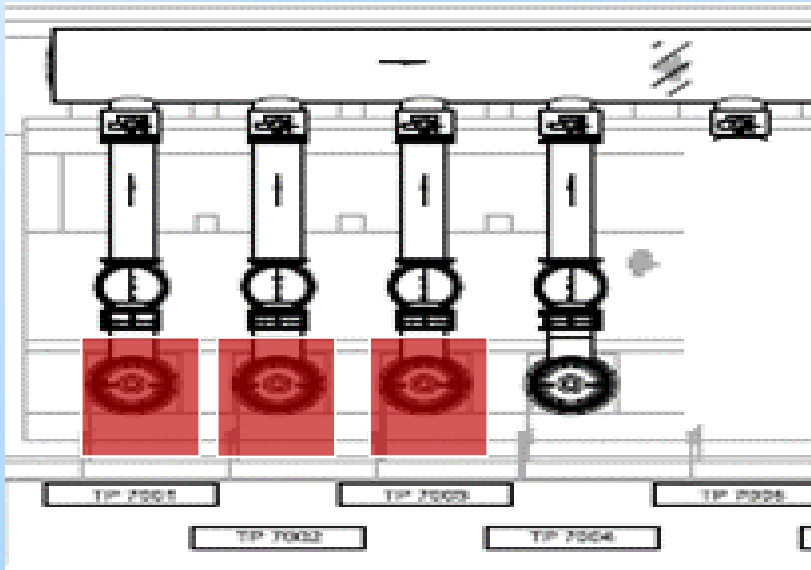
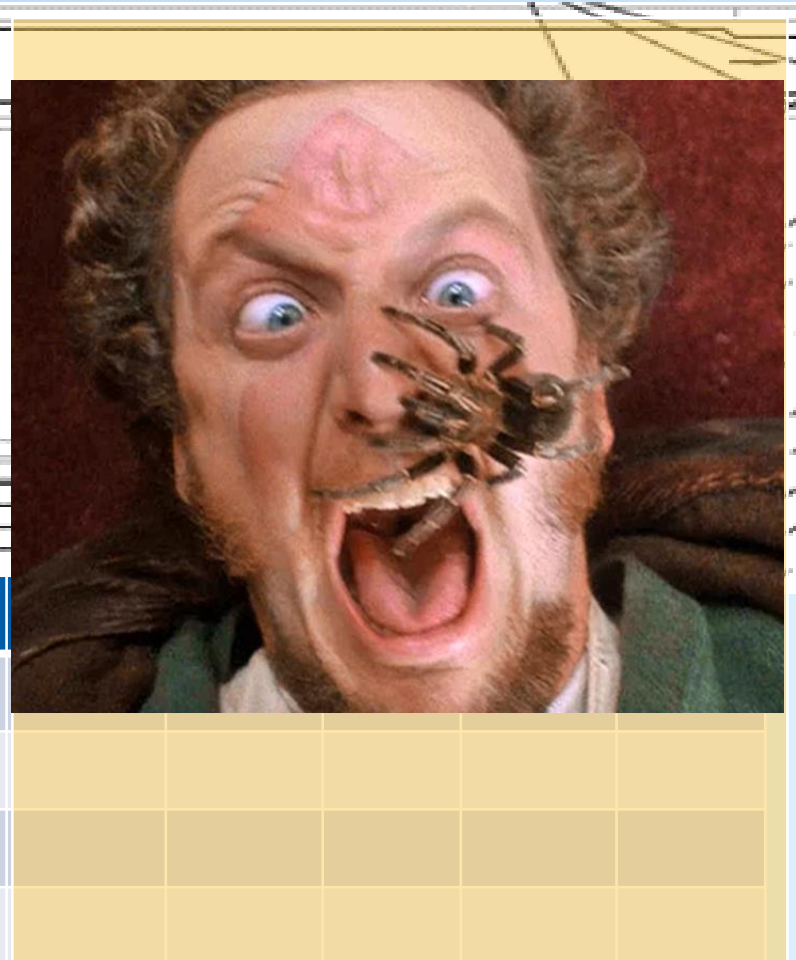
# ...and again...

Tag	7001	7002	7003	7004	7005
		2/24			
	3/2				
			3/6		
	~50 mgd capacity, new pumps

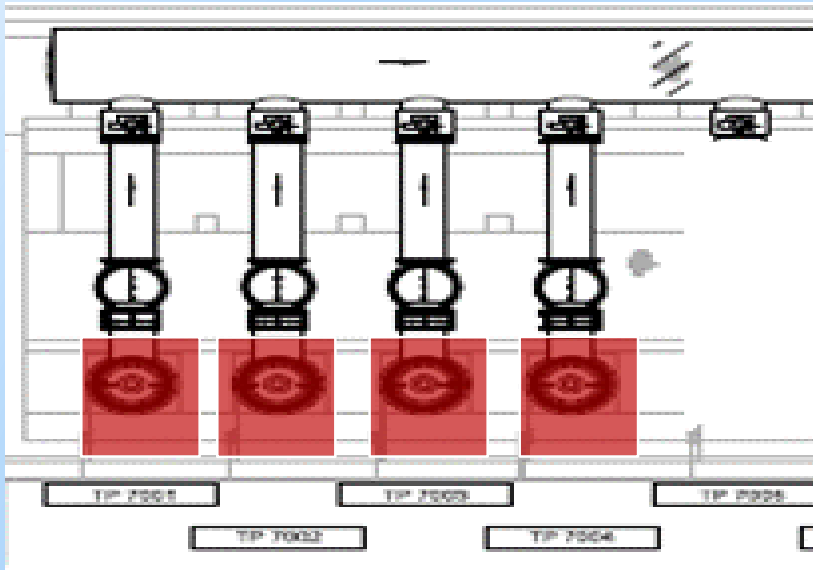
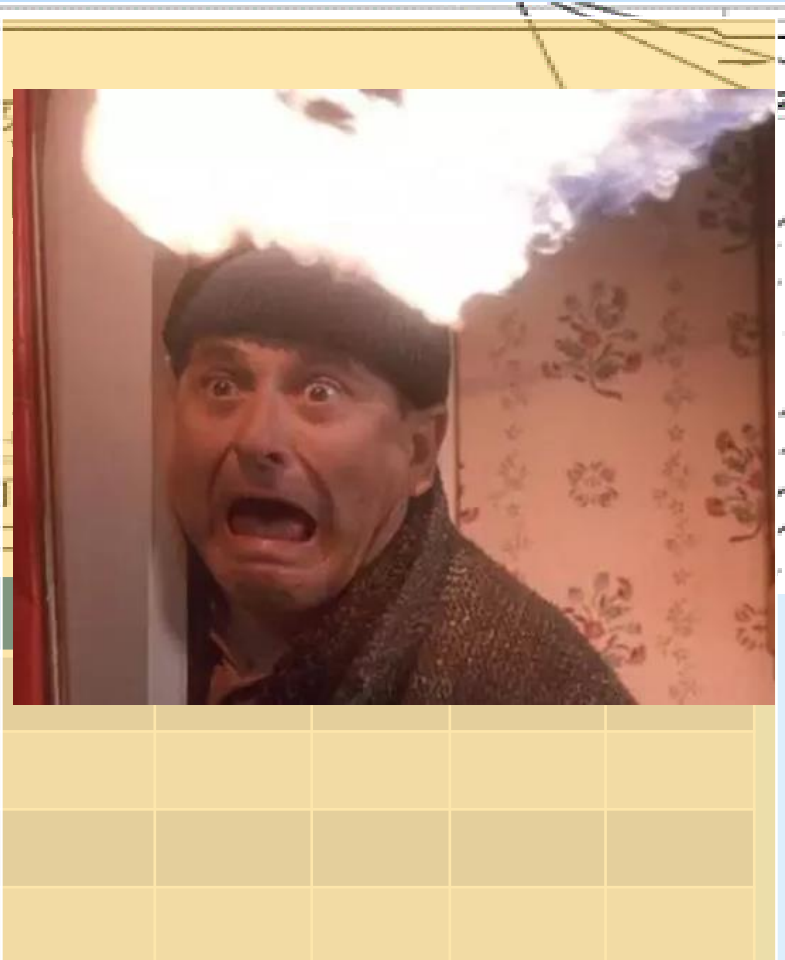
# ...until 4 new pumps fail in 2 weeks

Tag	7001	7002	7003	7004	7005
		2/24			
	3/2				
			3/6	3/8	
	~0 mgd capacity, new pumps

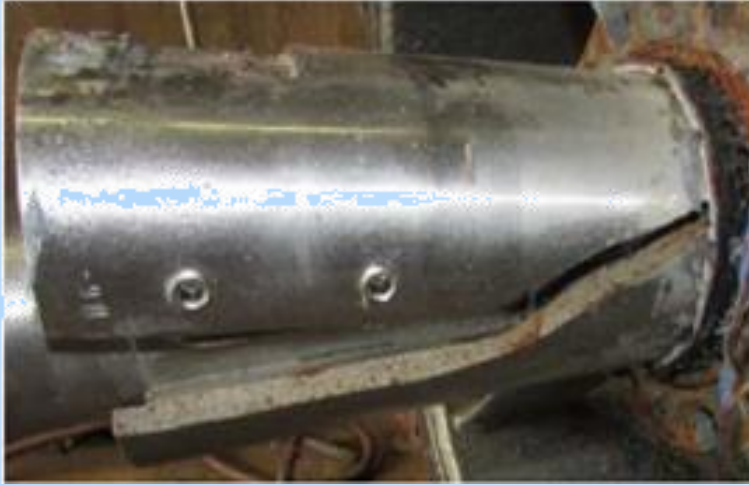
# Root cause analysis found coupling design and manufacturing problems

Broken shaft coupling sleeve (typical)

# A new coupling design was completed using finite element analysis

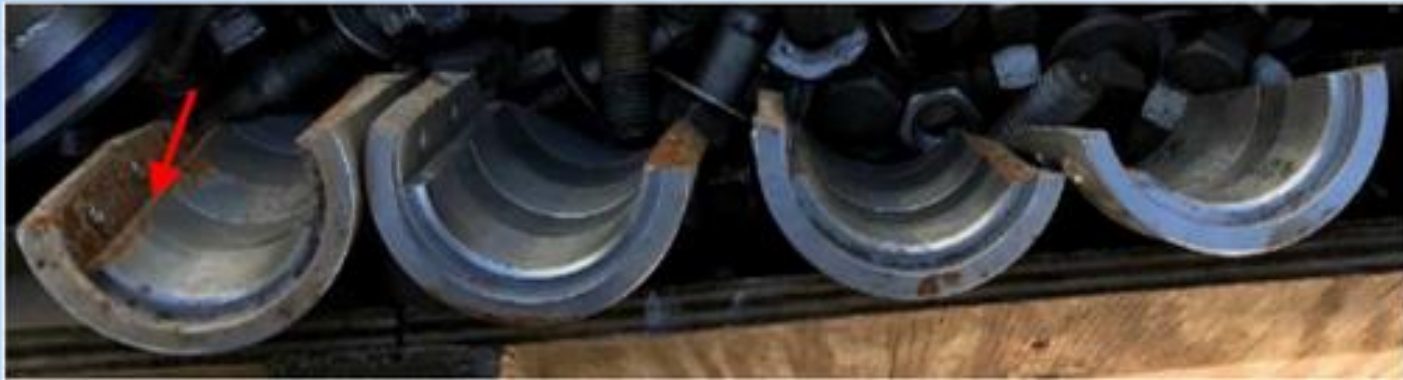
Broken shaft coupling sleeves, typical break patterns
